Manhole Inspection Summary

Manhole # S03YY1009MH

Insp Date: **8/14/06 12:00 AM**

Location Address: **6008 CLOVER RD** Cross Street: **PARKINGTON AVE**

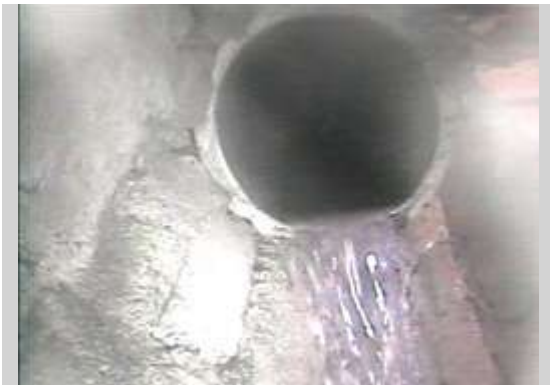
8 in. Circular Gravity Sewer Pipe In @ 3 O'Clock

Pipe Material: **Clay** ☐ Pipe Lined

Invert Depth: **7.42** (ft.) Flow Characteristics: **Fast**

Infiltration: **None** Pipe Seal Cond: **Sound**

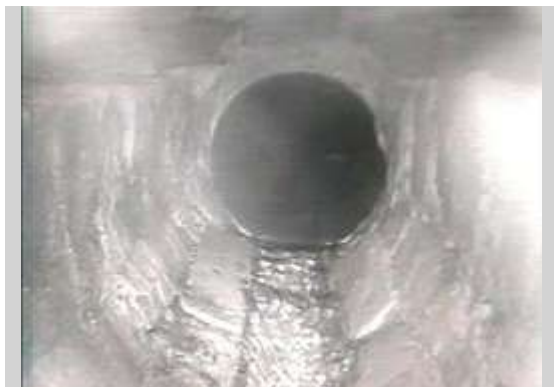
8 in. Circular Gravity Sewer

Pipe Material: **Clay** ☐ Pipe Lined

Infiltration: **None** Pipe Seal Cond: **Sound**
